Contract #: 04-0120F4Cty: SF/ALA Rte: 80 PM: 13.2/13.9File #: 69.28**WELDING INSPECTION REPORT****Resident Engineer:**Siegenthaler, Peter**Address:** 333 Burma Road**City:** Oakland, CA 94607**Report No:** WIR-023860**Date Inspected:** 19-May-2011**Project Name:** SAS Superstructure**OSM Arrival Time:** 700**Prime Contractor:** American Bridge/Fluor Enterprises, a JV**OSM Departure Time:** 1900**Contractor:** Zhenhua Port Machinery Company, Ltd (ZPMC), Changxing Island **Location:** Shanghai, China**CWI Name:** Mr. An Qing Xiang**CWI Present:** Yes No**Inspected CWI report:** Yes No N/A**Rod Oven in Use:** Yes No N/A**Electrode to specification:** Yes No N/A**Weld Procedures Followed:** Yes No N/A**Qualified Welders:** Yes No N/A**Verified Joint Fit-up:** Yes No N/A**Approved Drawings:** Yes No N/A**Approved WPS:** Yes No N/A**Delayed / Cancelled:** Yes No N/A**Bridge No:** 34-0006**Component:** Orthotropic Box Girder(OBG)**Summary of Items Observed:**

OBG Trial Assembly open yard.

Segment:13AW

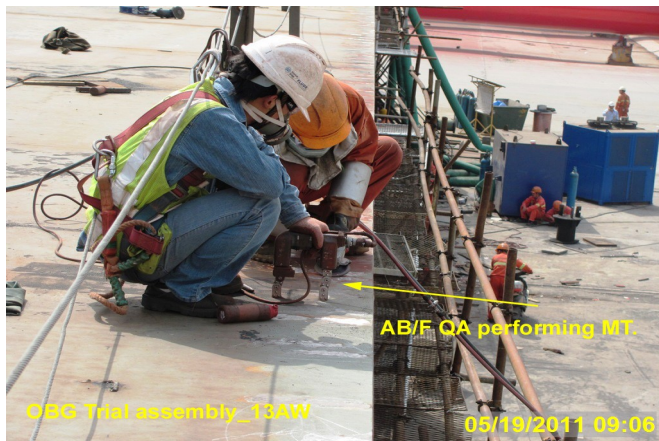
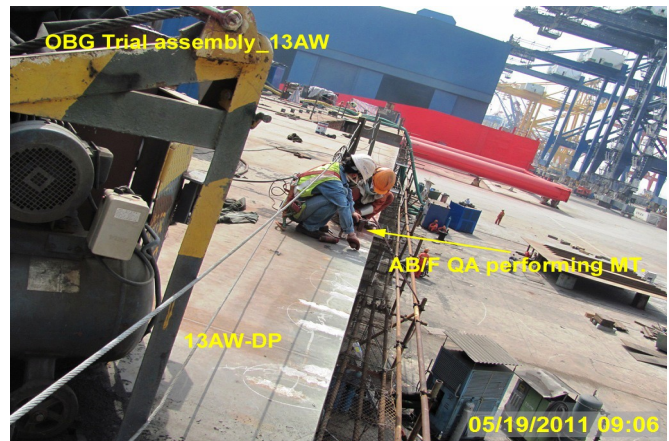
AB/F QA Inspector performing MT for the deck panel base metal repaired areas adjacent to the splice weld joint. See attached photos for further details.
